SURVEY STATEMENT

Name of vessel:	THORCO BASILISK
Owner:	MV Basilisk AG
IMO Number:	9539377

Survey station:	Houston
Place of survey:	Houston, Texas(USA)-Manchester Terminal
Survey started:	2022-07-27
Survey completed:	2022-07-27
Lead surveyor:	Ramalloso, Josue
Surveyor:

Crane Damage Surveys

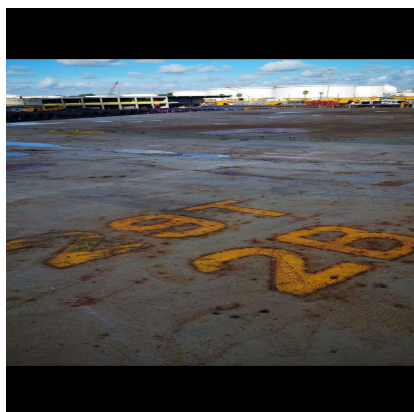
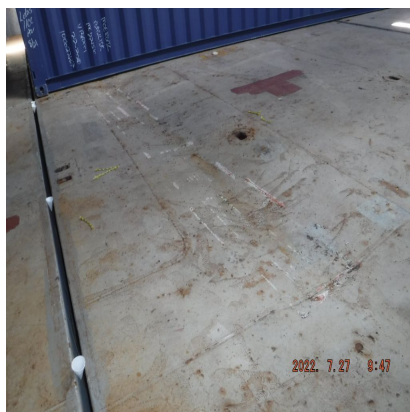
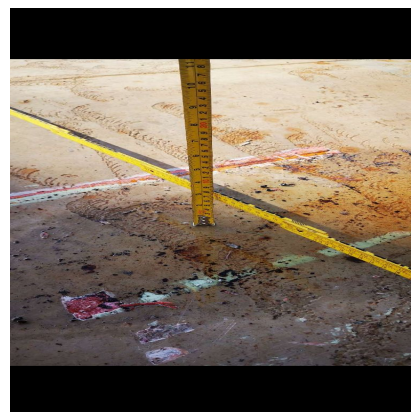
Cargo storing arrangements on decks and in spaces (Pending)

Indentation of about 60 mm on top of tween deck 2B in cargo hold 1 with an area of about 8 x 2 meters.

The indentations on tween decks 2B and 3S, including damaged substructures and side plate, in Cargo Hold 1 are to be repaired under supervision of a class surveyor.

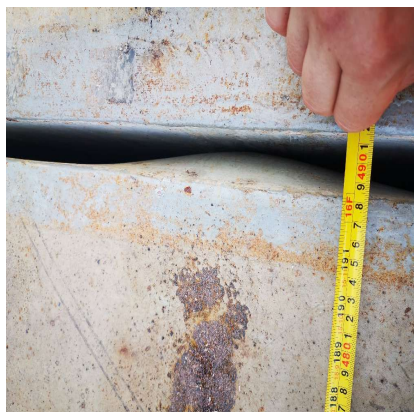
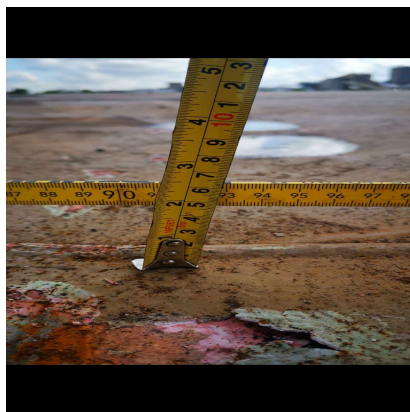
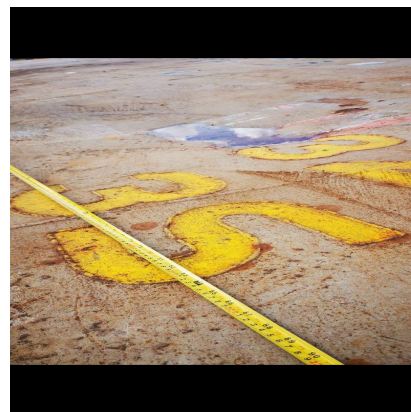
Cargo storing arrangements on decks and in spaces (Pending)

Indentations of about 50 mm on an area of about 5 x 2 meters, and bulging on 1 side plate by about 20 mm of tween deck 3S in cargo hold 1.

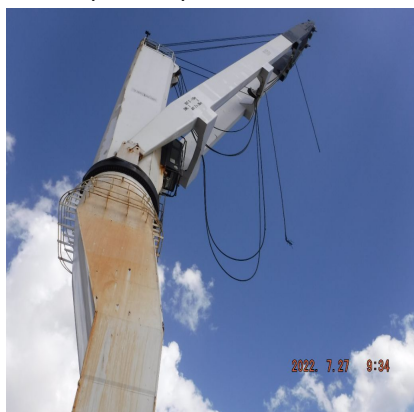
Shipboard crane arrangement 1F (Cargo 80T / 40T) (Pending)

Cut hoisting wire rope of Crane No.1 during cargo discharging operation. Crane 1F shall not be used until wire rope is replaced and load tested in presence of a class surveyor.

The damaged hoisting wire rope of Crane No.1 is to be replaced. The crane shall not be used until repaired, load tested and thoroughly examined as per rules.
